**The
Gladstone, Missouri
Water Distribution System**

- hydraulic model
- main breaks
- water quality

submitted
January 31, 2003

H₂O'C Engineering
2401 Tahoe Court
Columbia, MO 65203-1444
(877) 22-WATER
www.h2oc.com

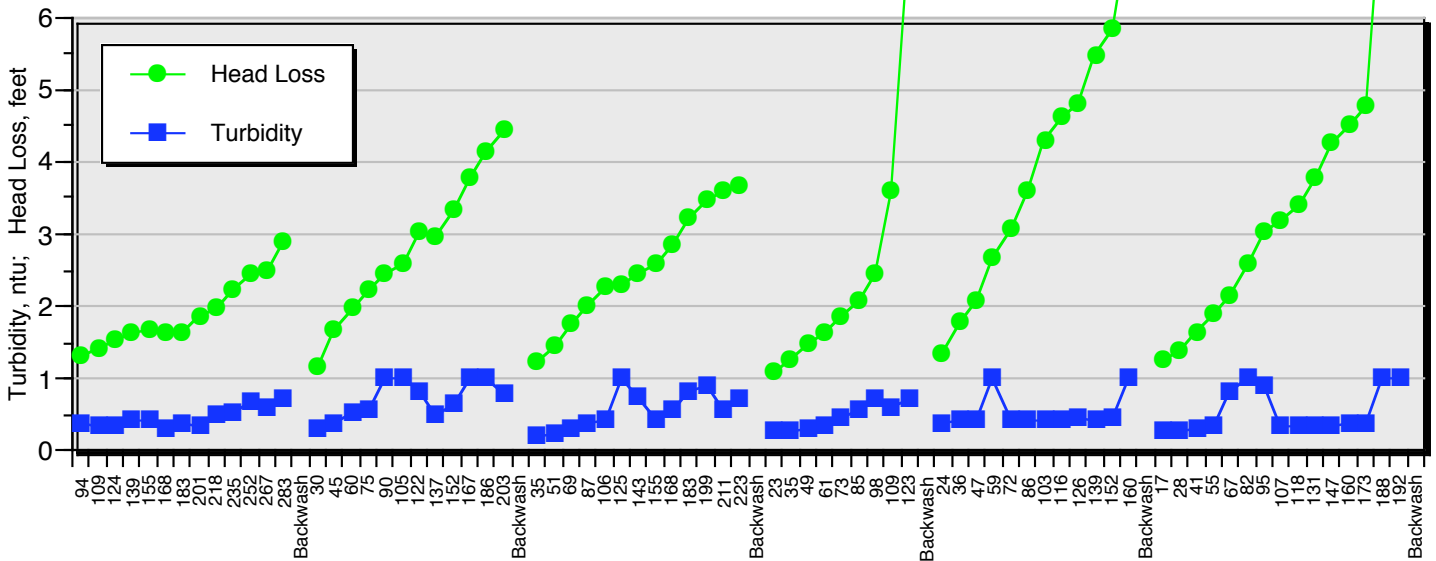
Filter #3 Performance: 5/1/98 to 7/17/98

Filtration cycles during 1998/1999 sometimes exceeded 200 hours. Several terminal head losses were well in excess of 6 feet. Commonly, toward the end of the filtration cycles, filtered water turbidities reached 1 ntu. While acceptable from a regulatory standpoint, these turbidities indicate the routine passage of solids through the filter.

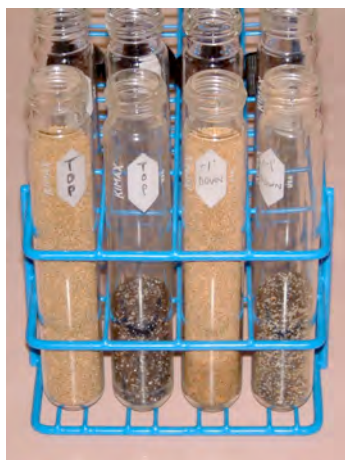
Media from both the surface and a one-foot depth within a filter was examined. The samples were washed with hydrochloric acid to remove the calcium carbonate buildup. This caused a decrease in weight and volume of over 60%. Both samples were found to contain primarily anthracite intermingled with a small amount of sand.

Cleaning the media required a large amount of strong acid and generated noxious gases. If the media was cleaned within the filters, the acid would attack the concrete and piping, and a substantial amount of additional media would need to be purchased to make up for the lost volume. Due to chemical and media costs, potential health hazards, and likely damage to the plant, replacement would be safer and more cost-effective than cleaning.

There are several current concerns related to the condition and capacity of Gladstone's four existing filters. First, the media in each filter has grown to the point where media replacement is clearly required.

For these reasons, the media should be simply be replaced rather than acid-treated.

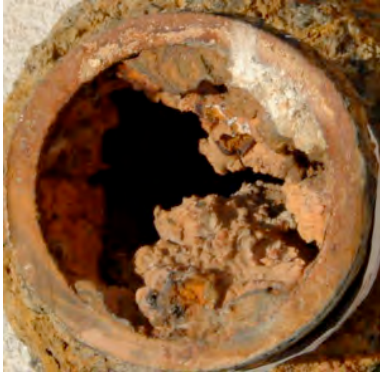
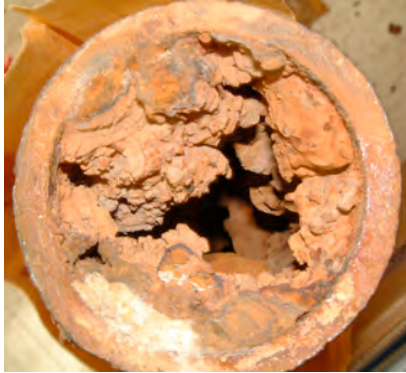
Severely Encrusted 2" Pipes

Pipes that had been removed from service showed varying degrees of encrustation. Generally, the smaller pipes exhibited more encrustation, presumably due to greater surface area and lower flows. Some 2" pipes appear to have only a small fraction of their rated flow capacity available. Since smaller pipes break more frequently, selection of larger pipe may help reduce breakage rates in the system.

The hard scale (encrustation) on many pipes appears to be composed of iron and calcium carbonate deposited from the lime-softened water. There is little evidence of tubercle or pit formation resulting from corrosion on the interior of the pipe.

While the recommendations in this report are intended to help minimize the number of main breaks, many pipes in the distribution system are over fifty years old, and eventual pipe replacement is inevitable. Due to age and encrustation and the resultant increase in breakage and decrease in flow, many pipes in the distribution system will need to be replaced in the foreseeable future. At that time, a pipe replacement plan should be developed, and alternate materials should be considered (PVC, HDPE).

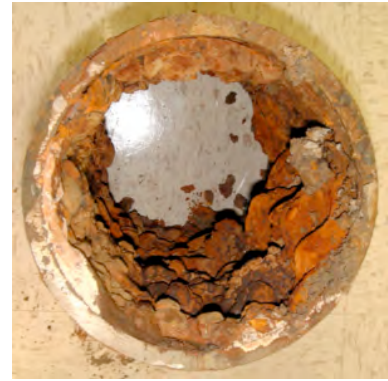
Encrusted 8" Pipe

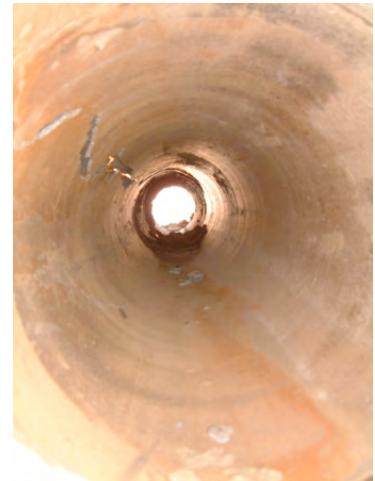
Despite the severity of encrustation in some smaller pipes, the ruptured 12" main (right) showed none whatsoever.

Clean 12" Pipe

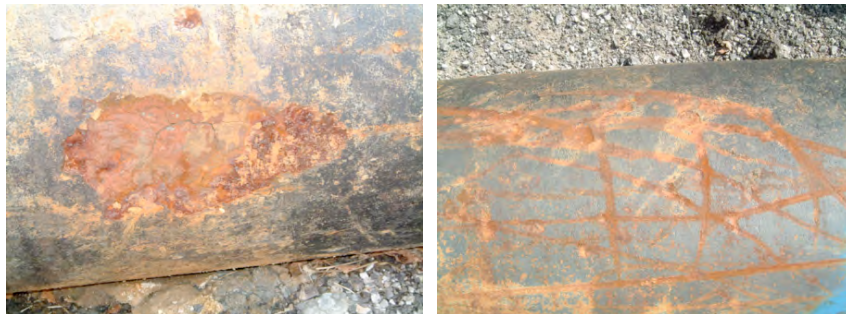
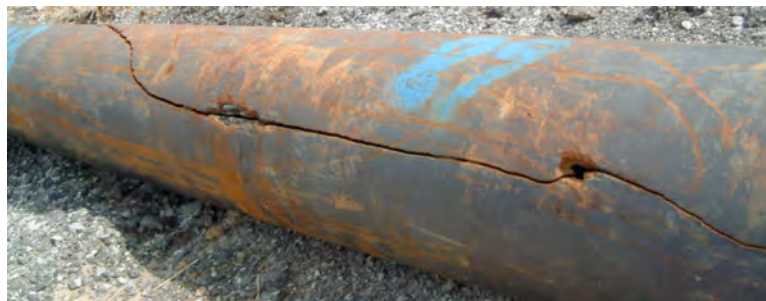
External corrosion was clearly visible on sections of ductile cast iron pipe that had been removed from service due to failure. Rather than occurring uniformly across the pipe surface, corrosion was localized. In the illustration below, whereas the pipe appears to be in generally good condition, a longitudinal break has occurred along a line passing through two large and deep external pits.

Longitudinal Break through Two Distinct Corrosion Points

Representatives of the Ductile Iron Pipe Research Association (DIPRA) performed an analysis on seven soil samples from Gladstone. Their report is appended. Citing the low resistivity of the soil (440 to 1,400 ohm-cm), their conclusion was that “the water main corrosion has occurred as a result of corrosive soil conditions.”

Other factors, such as soil pH (6.8 to 7.2) and oxidation/reduction (redox) potential (+190 to +342 mV), did not suggest a corrosive soil. Additionally, the pipe sections removed from service due to failure did not exhibit uniform corrosion along the surface, but rather discrete points of corrosion.

The Ductile Iron Pipe Research Association (DIPRA) recommends that external corrosion be inhibited by the use of low density polyethylene (LDPE) plastic wrap applied at the time the pipe is installed. LDPE pipe wrap is available in thickness' of 8 to 14 mil at a cost of less than 35¢/foot.
