Recirculating Hot Water Systems

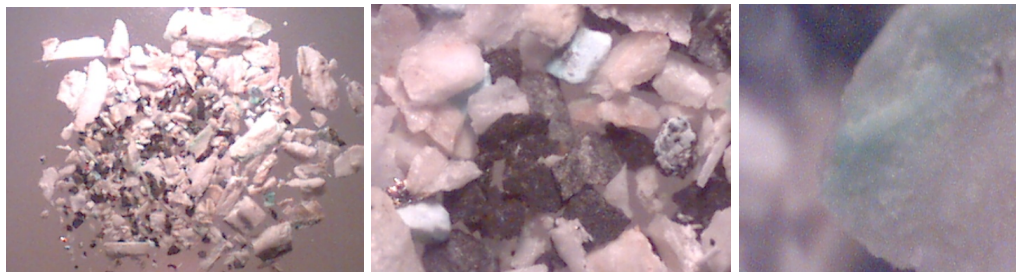
A predominately white, hard scale was scraped from a bathroom tap at the Marler residence. The appearance and hardness of the scale seemed typical of calcium carbonate.

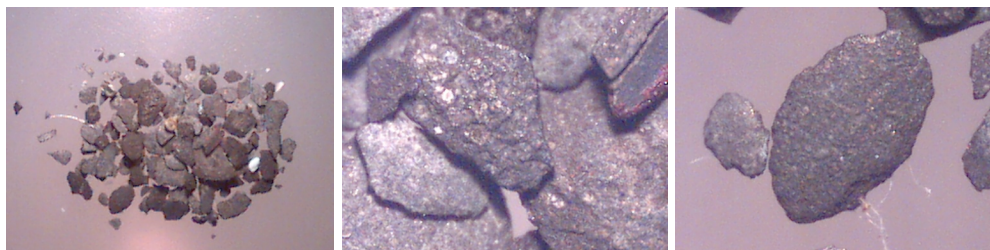
Removal of the faucet aerator screen revealed the presence of predominately black, hard flakes that were retained on the screen.
