# **Pit Happens**

Copper Corrosion in Household Plumbing

Tom O'Connor, PE H2O'C Engineering Columbia, MO 65203

#### **Copper Corrosion Problem in Household Plumbing: A Case Study**

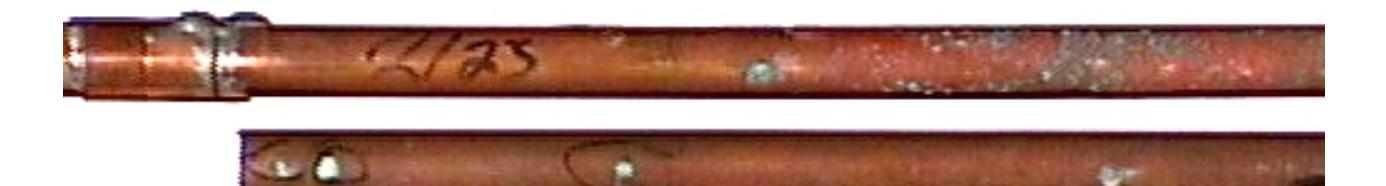
Examination of pipe removed from the households provided substantial evidence for the findings of the present study. While not universally true, it appeared that much of the corrosion occurred in the middle of copper runs rather than near the joints of the pipe. This evidence did not support the contention that improper joining techniques were responsible for the pipe failures. Where improper installation is observed, particles of copper (chips from burrs) or excessive amounts of aggressive flux are spalled into the pipe in the vicinity of the joint. These particles of copper or flux may become points or discontinuities at which copper pitting corrosion is initiated.

Exterior view of copper pipe (top) shows pitting starting 6 inches from joint. External view of horizontal copper pipe run (bottom) shows series of aligned pits

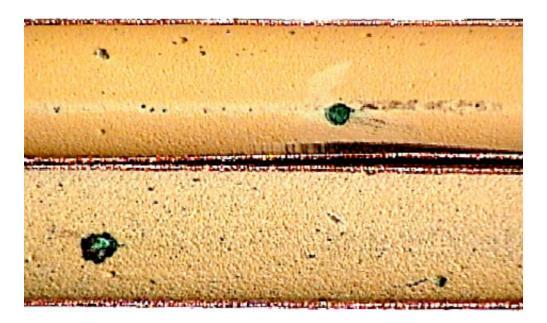
Despite the fact that most corrosion has occurred in Wolverine type M pipe, one homeowner was able to provide one sample of Cerro brand pipe which had developed pits while in service. Another homeowner reported replacing large amounts of Wolverine and another brand of pipe (possibly Cerro) in a roughly 80%/20% ratio. Both brands showed similar patterns and degrees of pitting corrosion. This would indicate that the pitting corrosion of the copper pipe was generic and not due to an individual "bad batch" of pipe.

Interior Sections of Wolverine (top) and Cerro Pipe (bottom) showing circular pit formation. Note incipient formation of numerous pits along horizontal line in pipe at top.

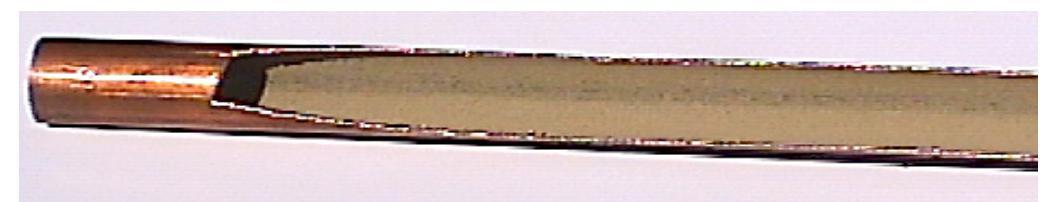
The pipe sections examined showed no evidence of internal "erosion corrosion." Erosion corrosion creates stream lines or grooves (striations) which result from excessive water velocities. To avoid this condition, it is generally recommended that pipe diameters be large enough to limit flow velocities to less than 5 feet per second (fps) in cold water lines; 4 fps in hot water lines, and 3 fps in recirculating hot water systems. From these recommendations, it appears that hot water recirculating systems are most at risk.

Pipe sections without obvious pits show uniform deposits of soft magnesium precipitates. There are no stream lines or evidence of microbial slime build-up.

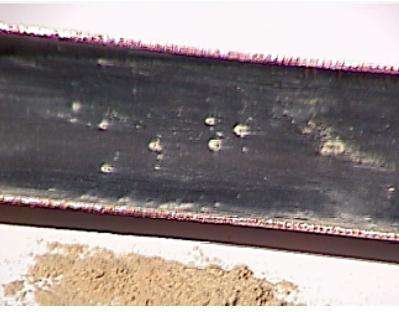
Fingernail removal of soft scale reveals hard (black) cupric oxide surface coating and hidden incipient pits.

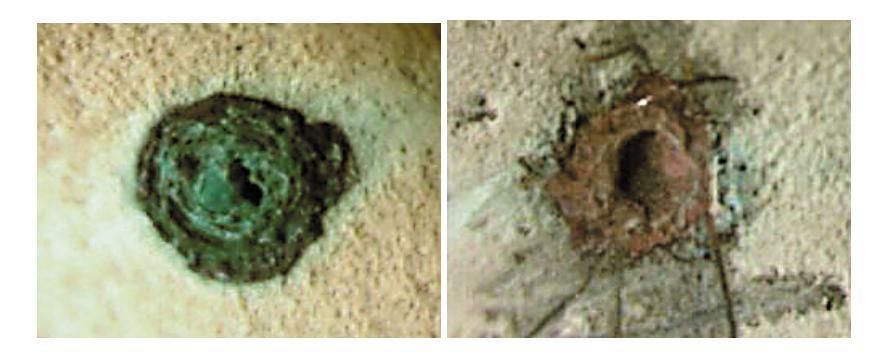
Interior view of pits, before and after scraping to remove blue-green copper precipitates

Where significant corrosion had occurred, there were small (2 to 3 mm), circular discontinuities containing crystalline, blue-green precipitates (possibly, a mixture of copper sulfate and malachite, a coprecipitate of copper carbonate/copper hydroxide). These discontinuities appeared to serve as pinpoint anodes at which copper corrosion (oxidation) proceeded until the tube wall was pierced. Often, the same blue-green precipitate was also evident on the outside of the tube.

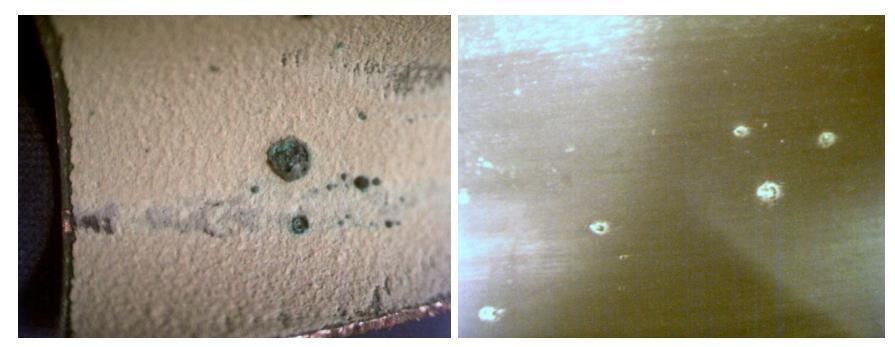
Interior copper pipe surface, before and after removal of soft scale
