**Filter Media Cementation  
at the Oakwood Water Treatment Plant,  
East Peoria, Illinois**

submitted  
December 17, 2002

H<sub>2</sub>O'C Engineering  
2401 Tahoe Court  
Columbia, MO 65203-1444  
(877) 22-WATER  
[www.h2oc.com](http://www.h2oc.com)

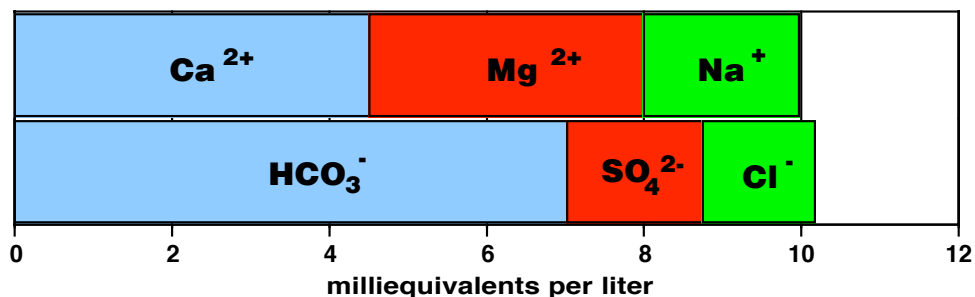
Water Composition - Well #10

Well #10 produces water that is hard (approximately 400 mg/l as CaCO<sub>3</sub> equivalent), but very low in iron and manganese (< 0.1 mg/l combined). This water also appears to be non-corrosive (neutral in pH) and has little tendency to deposit scale on the interior of distribution system piping or household plumbing. Accordingly, this water is pumped directly from the well to the distribution system without treatment except for chlorination.

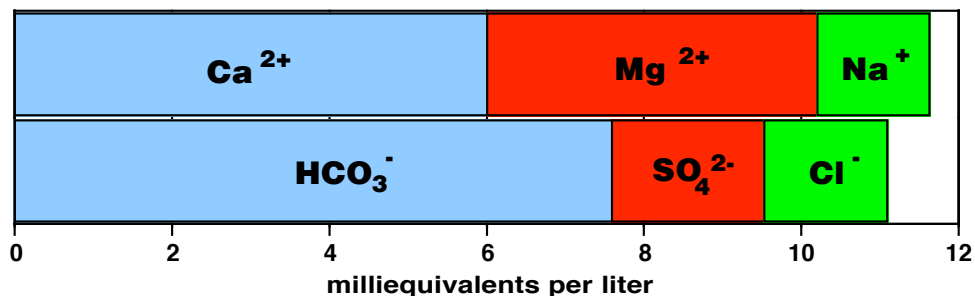
Water Composition - Wells #11 and #12

Wells #11 and #12 serve as influent to the Oakwood Road Water Treatment Plant. While somewhat harder and higher in alkalinity, these well waters are similar in inorganic composition to the water from Well #10 except they contain noticeable amounts of iron and manganese. In these waters, ferrous ion has been measured in the range of 0.7 to 1.8 mg/l Fe, while manganous ion averaged 0.23 mg/l Mn.

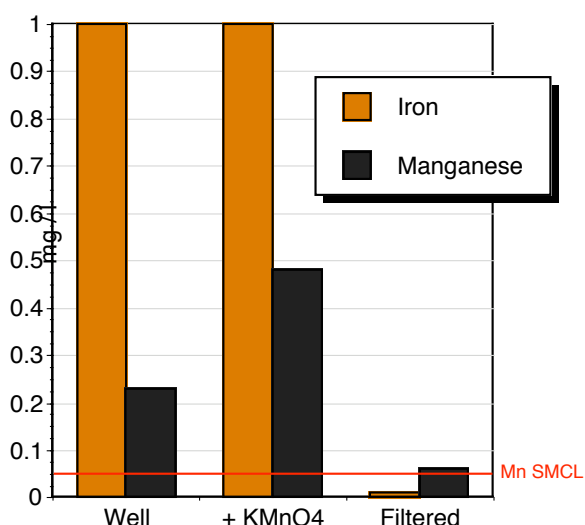
Accordingly, the Oakwood Road Water Treatment Plant was designed to remove the relatively small quantity of solids formed when iron and manganese are precipitated from Wells #11 and #12. The bar chart shown below illustrates the almost total (99%) removal of iron and the 80% removal of manganese in November 2002.

Manganese removals vary owing to the addition of potassium permanganate to the filter influent. Depending upon variations in feed rate, permanganate addition adds approximately 0.25 mg/l Mn to the influent water, bringing the total to roughly 0.48 mg/l Mn. Any transient overfeed of permanganate can result in the passage of 'pink water' plus increase the manganese concentrations in the filtered water. This suggests that the permanganate feed should be reduced to the minimum consistent with the maintenance of filtered water Mn concentrations less than 0.05 mg/l.

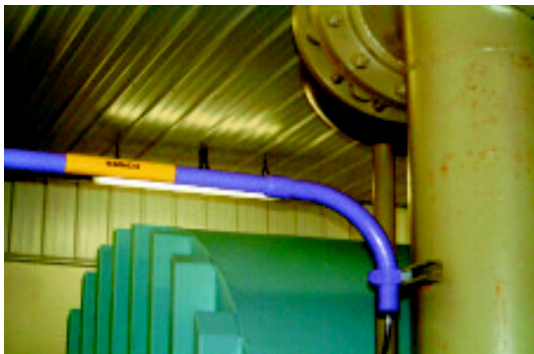
Permanganate is added to aerated water (filter influent) to oxidize manganous ion ( $\text{Mn}^{2+}$ ) to  $\text{Mn}(\text{OH})_4$ , a brown-black precipitate.

To minimize solids application to the filter units, the permanganate addition should be reduced to the lowest possible effective dose. To determine the lowest effective dosage, the chemical feed should be incrementally reduced while plant influent, filter influent, and finished water are analyzed for manganese.

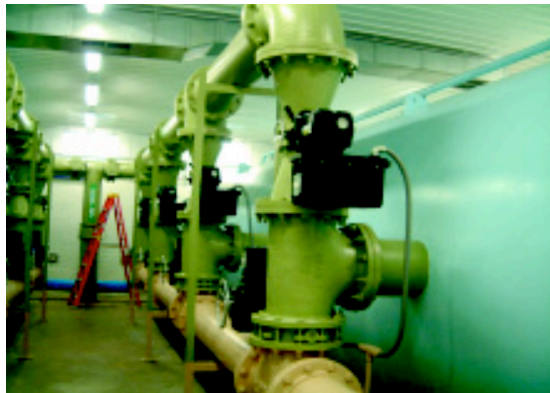
Horizontal pressure filters are divided into four compartments containing dual, crushed anthracite coal and coarse sand, media

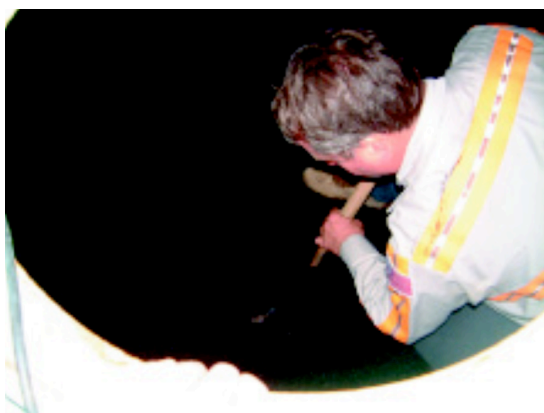
Filter media probing and sampling were conducted on November 18, 2002.

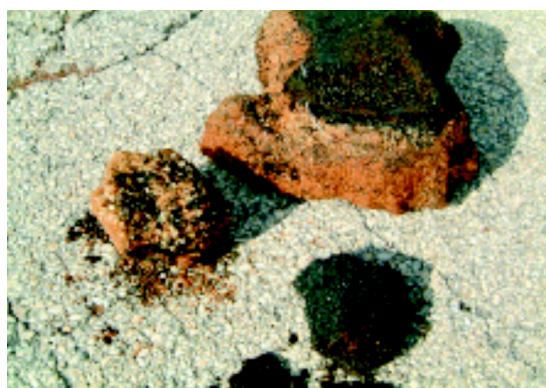
Most of the severely cemented (sandy) material appeared to underlie the anthracite layer. The anthracite also showed evidence of a loose aggregation that could be broken up by hand.

From the most recent filter media sampling at the Oakwood Plant, it appears that it is primarily the underlying sand layer that is undergoing cementation. This might be expected since the sand layer, being far greater in density (specific gravity, 2.6) as well as larger than the anthracite (specific gravity, 1.6), would not expand as much, if at all, during backwash. As a result, the surface deposition of calcium carbonate and iron oxides on the sand would be less efficiently removed.

The addition of sulfuric acid to cemented media results in significant effervescence of carbon dioxide. Upon acidification, 25% of the sand layer sample, by weight, was lost. This is in contrast with the loss of 8.5% by weight following acidification of the anthracite layer.

Under the current circumstances, there seems to be little choice but to remove and discard the cemented filter media before encroaching filter blockage reaches the point where water production is significantly impaired. Attempts to rehabilitate existing media with acid have not exhibited long-term effectiveness. Additionally, acid treatment generates noxious fumes, attacks the filter itself, and still requires the addition of media to make up for the material lost through acidification.

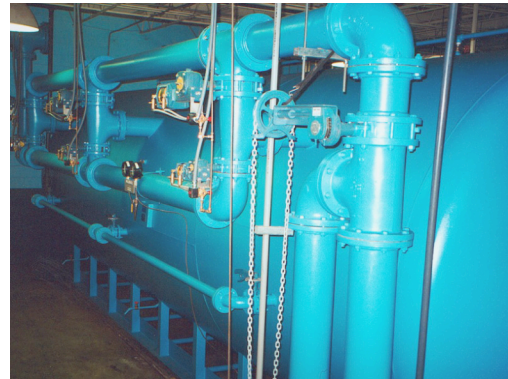
The photo at right shows a new pressure filter in Morton, IL. Piping for air scour is visible at the bottom left of the picture.

The existing filter units should be outfitted with an air injection system. PVC distribution piping for the system should be located beneath the sand layer, preferably within the underdrain system. Air holes should be small enough to keep the media out of the air lines. A blower capable of supplying air at a rate of 2 to 4 ft<sup>3</sup>/min/ft<sup>2</sup> should be selected.
