Investigation of Water Quality Issues

submitted to the City of Red Bud

March, 2014

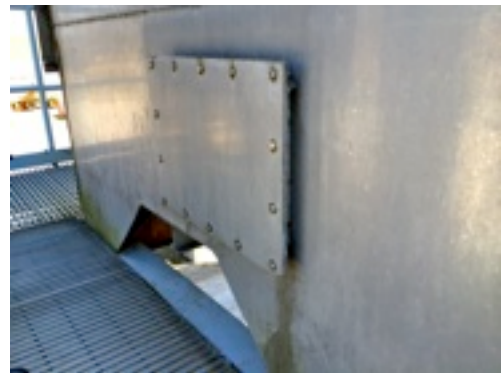
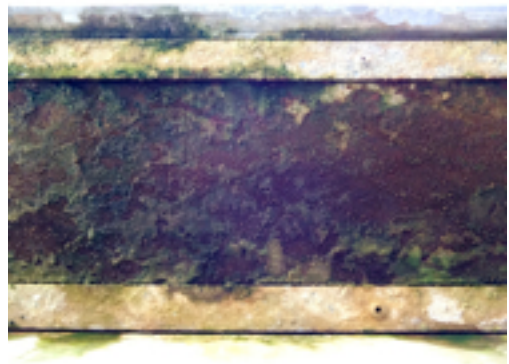
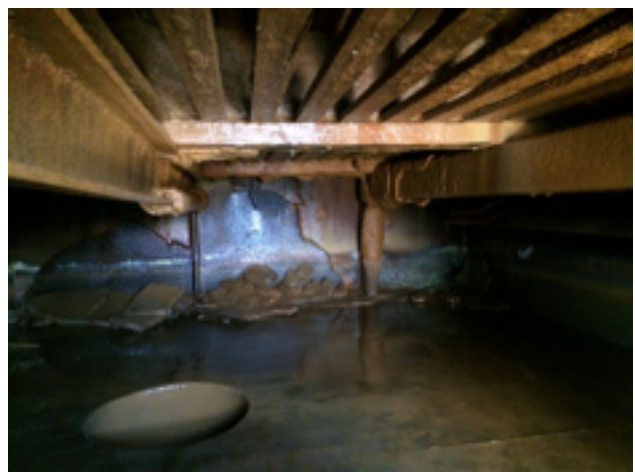
The existing aerator is a Hydro Group IDA 78-10, which is an induced-draft wood slat aerator. Although it is not simple to open and fully examine the interior, there is a small service hatch near the bottom that was removed.

Staff reported that there may be an issue with the fan which causes it to blow air in the wrong direction (downwards into the unit). This should be remedied. The need for a fine screen held on to the fan with a bungee cord should be reevaluated, as this restricts air flow.

The side air intake vent screens are encrusted with debris that severely inhibits air flow. These screens should be cleaned or replaced with coarser screens that allow better air flow and don't get clogged as easily.

Based on a peek inside the small access panel, the interior of the aerator appears to be in decent shape. The wood slats are intact, and there is not a large amount of solids buildup. At some point, the large side of the aerator should be removed for a more thorough inspection and cleaning.

In order to evaluate the performance of the aerator, it would be helpful to have a sample tap at its effluent. This would allow staff to monitor aerator performance on an ongoing basis (via pH, dissolved oxygen, and organics).

1. Clean aerator intake screens, ensure proper operation of forced draft fan.
2. Open side of aerator for thorough inspection and cleaning.
3. Install a raw water sample tap and an aerated water sample tap.

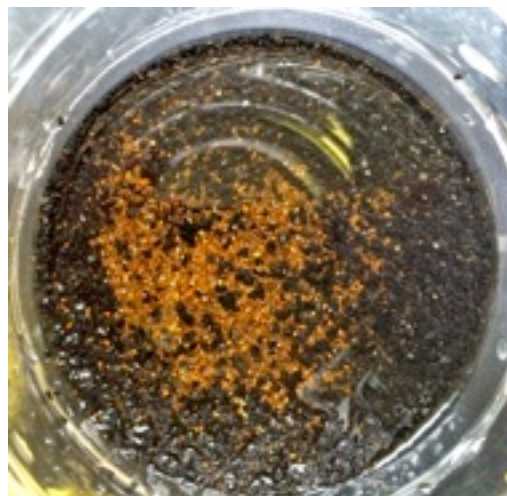
A grab sample from the plant's filter media appeared extremely clean and showed no signs of significant biological growth. Additionally, both the sand and anthracite were free of encrustation from calcium carbonate or any sort of buildup.

Microbiological growth tends to be associated with dissolved oxygen depletion, so DO was measured in the raw water, through the water treatment plant, and at several points in the distribution system. Even in the farthest reaches of the system, there was no significant oxygen depletion, as oxygen levels remained near saturation.
