**The
Gladstone, Missouri
Water Distribution System**

- hydraulic model
- main breaks
- water quality

submitted
January 31, 2003

H₂O'C Engineering
2401 Tahoe Court
Columbia, MO 65203-1444
(877) 22-WATER
www.h2oc.com

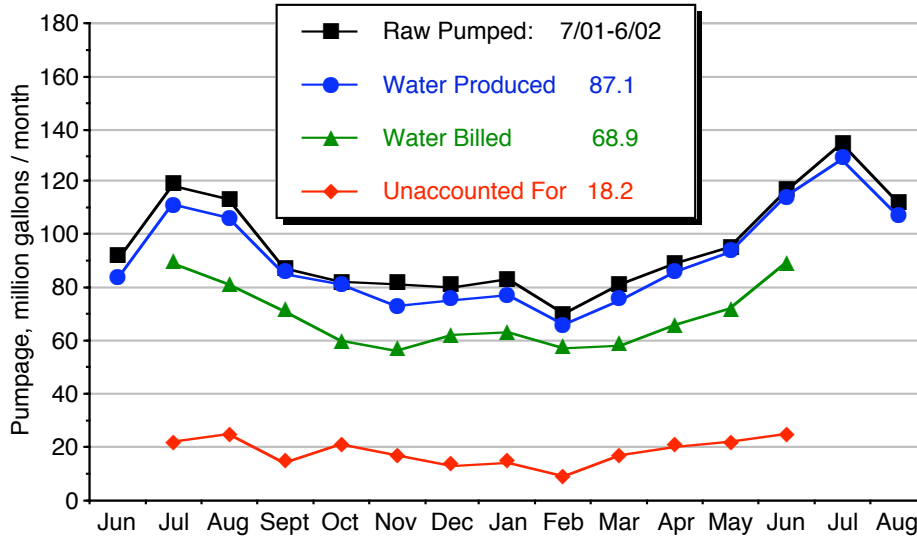
Gladstone 'Unaccounted for' Water: 7/01 - 6/02

(Water Produced - Water Billed = 20.7% Unaccounted)

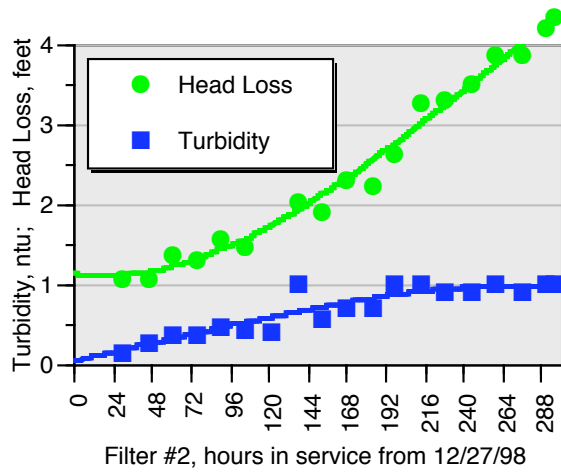
Individual filters which suffer excessive head losses (greater than 4 feet) or allow the consistent passage of turbidity in excess of 0.4 ntu may have to be backwashed more frequently than 96 hours. For example, 1998/1999 records show that Filter #2 routinely exhibited head losses in excess of 4 feet. This was generally accompanied by high turbidities and may indicate encrustation of the underdrain system, mudball formation or filter blockage.

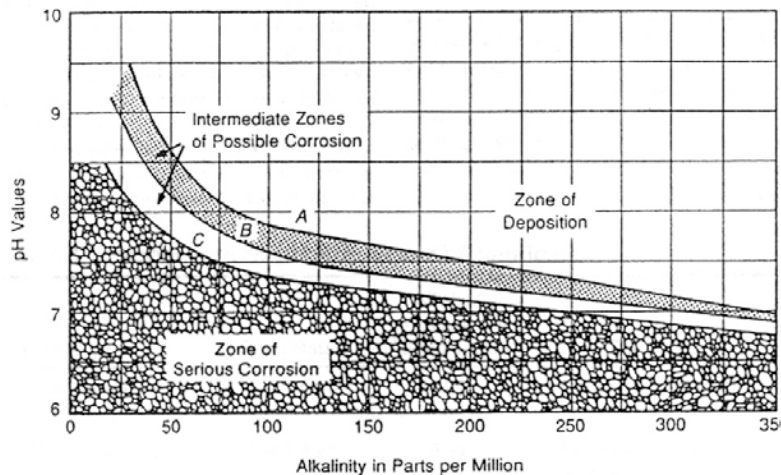
The Baylis Curve illustrates the degree of saturation of water with calcium carbonate based on pH and alkalinity. For Gladstone's finished water, pH has been in the range of 9.3 and alkalinity approximately 50 mg/l as calcium carbonate equivalent. This would indicate that calcium carbonate is well within the "Zone of Deposition".

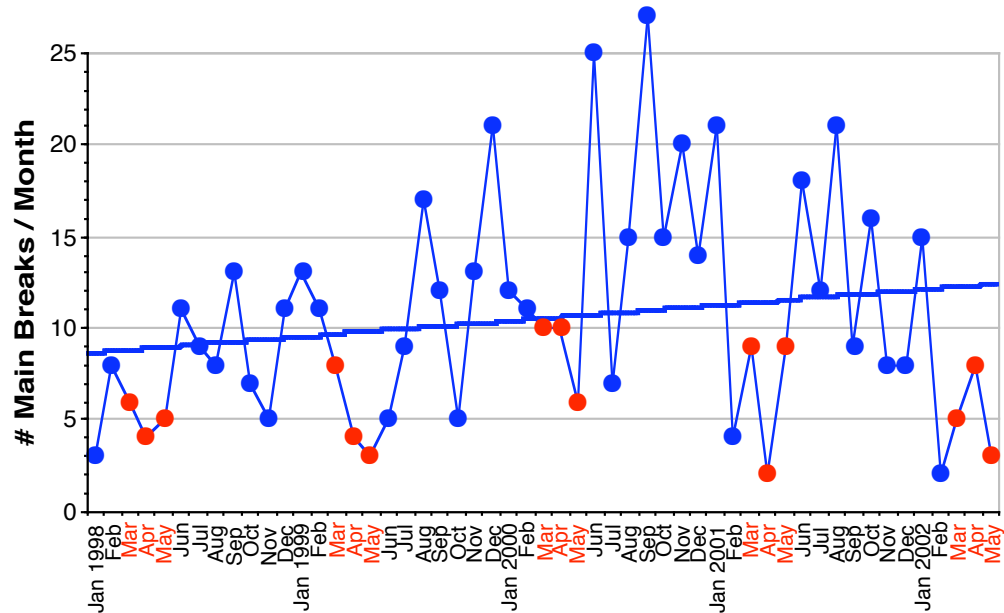
Number of Main Breaks per Month: 1998 to 2002

A plot of the number of main breaks per month in Gladstone (above) indicates that there is some seasonal relationship between the rate of breakage and distributed water temperature. The number of monthly breaks reported are consistently below Gladstone's average in March, April and May, the months when Gladstone's distributed water temperatures are lowest. During these months, the underground mains would be expected to be at their shortest due to contraction.

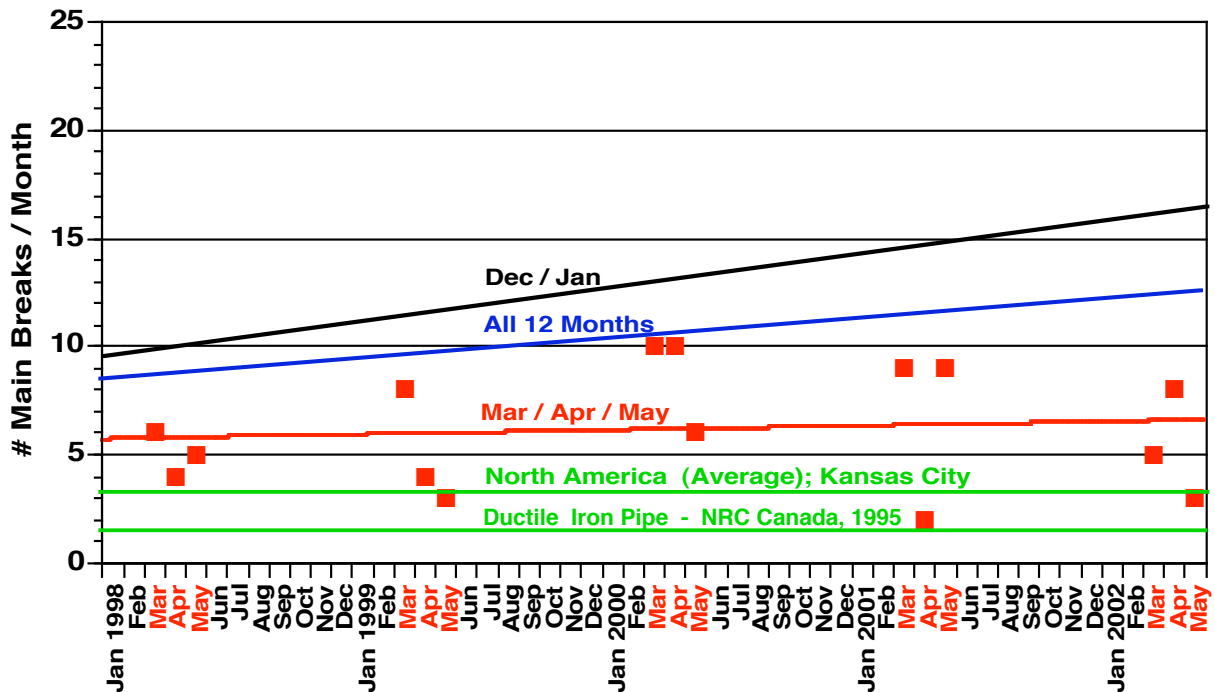
Trends and Seasonality of Gladstone Main Breaks versus North American Norms

Further examination of main repair data from 1998 to 2002 indicates that the rate of main breakage in Gladstone (blue trend line) has been increasing. This may be attributable to increasing pipe age and ongoing corrosion.

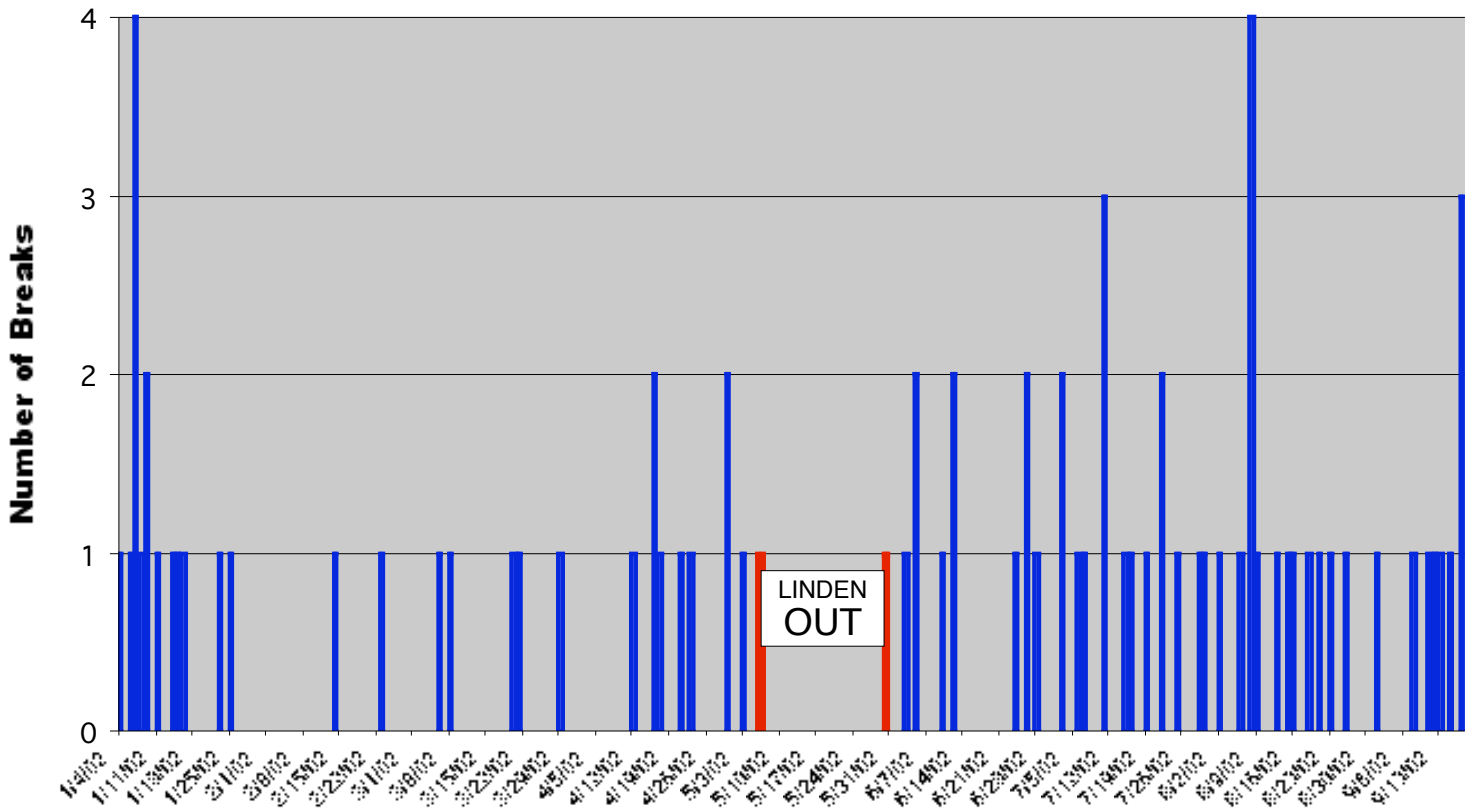
Gladstone Main Breaks - 2002

The number of main breaks, by day, is shown in the plot, above, for the year 2002. The number of breaks ranges from 0 to 4 breaks per day.

For a number of days (the period shown between the red bars), there were no recorded breaks in the Gladstone distribution system. During this period, the Linden water tower was out of service. As a result, system pressures would have been somewhat lower and the cycling of pumps, on and off, to fill the tower would have diminished. This empirical evidence suggests that lowered pressures, or even the removal of the Linden water tower from service, might markedly reduce breakage.
