Recirculating Hot Water Systems

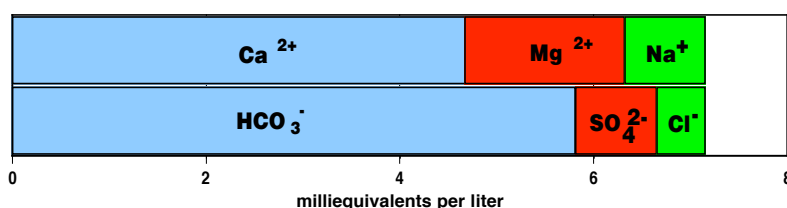
Kearney Well Water (Average Composition)

Recarbonation, the application of carbon dioxide gas, is practiced prior to filtration in order to reduce the high pH resulting from the addition of lime and stabilize the water with respect to calcium carbonate post-precipitation. The finished, filtered water is neither corrosive nor greatly supersaturated with respect to substances that will deposit in the mains and household plumbing.

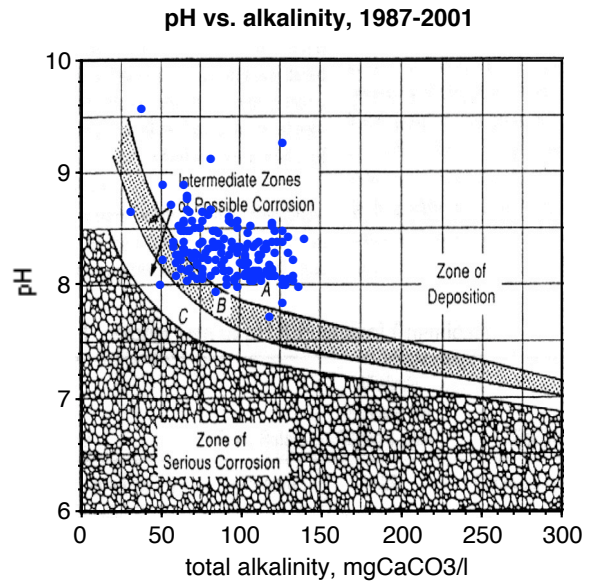
Although there are no specific standards for these parameters, pH is commonly maintained at 8.0 or above and alkalinity above 20 mg/l as calcium carbonate equivalent. Kearney's water supply has consistently been well above both of these values for more than the past decade. Even with the installation of facilities for recarbonation in 1993, sufficient alkalinity has been maintained to ensure continued supersaturation of the finished water with respect to calcium carbonate. As a result, the Kearney water supply has not exhibited high concentrations of lead or copper at consumers taps.

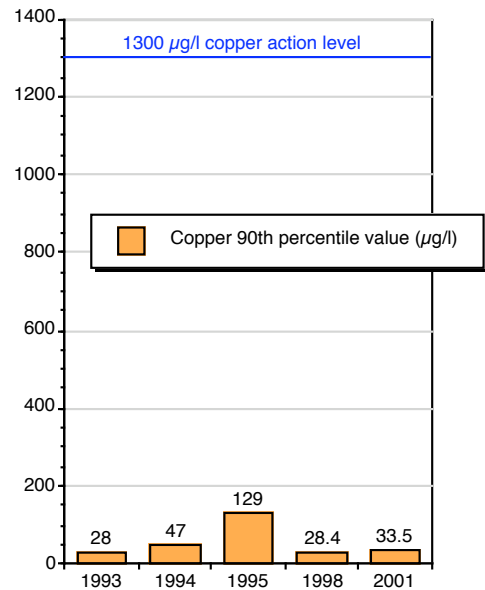
Results of testing under the Lead and Copper Rule (graph at right) indicate that copper levels are consistently low, and the 90th percentile values used to determine compliance are well below the 1,300 $\mu\text{g/l}$ copper action level. This indicates that Kearney's finished water is not inherently aggressive towards copper.
